Wrong-Way Driving

Special Investigation Report

NTSB/SIR-12/01 PB2012-917003

Highway Special Investigation Report

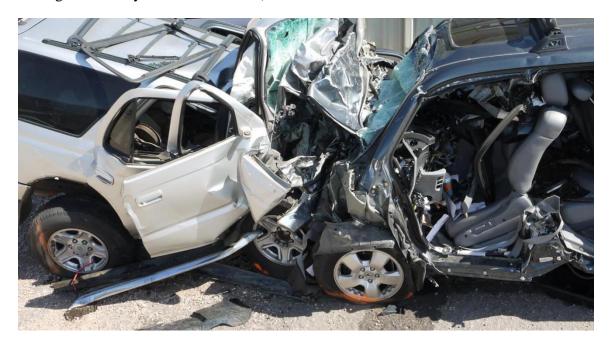
compared to all other accidents on controlled-access highways.⁷ A study in Michigan found that 22 percent of wrong-way collisions were fatal, compared to 0.3 percent for all highway accidents in the same time frame.⁸ (See figure 1 for a postaccident photograph of the two vehicles involved in the 2011 Fountain, Colorado, wrong-way driver collision, discussed later in this report, illustrating the severity of such collisions.)

Figure 1. Postaccident view of the vehicles from the Fountain, Colorado, wrong-way collision.

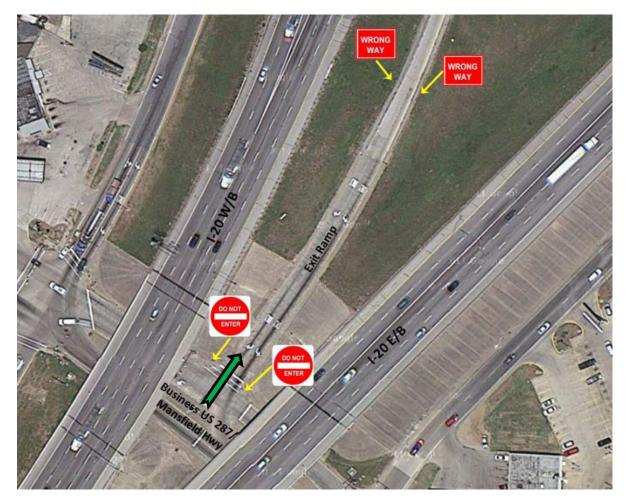
NTSB investigators reviewed witness statements and examined ramps in the vicinity of the collision to determine the location where the SUV driver most likely began to travel the wrong way on I-20. Based on the configuration of the exit, the wrong-way entry point was probably the Business US 287/Mansfield Highway exit for westbound I-20 motorists. The ramp has overhead roadway illumination. The SUV driver would have merged into the travel lane going the wrong way from the exit ramp onto I-20 and traveled in the number three lane for about 2.5 miles before striking the Toyota and the combination vehicle.

The Business US 287/Mansfield Highway exit is equipped with two 48- by 48-inch "Do Not Enter" signs posted about 90 inches above the ground at the crossroad; one "Do Not Enter" sign is oriented southwest to increase its visibility to motorists traveling north on the crossroad, and the other sign faces west. The exit also has two 24- by 36-inch "Wrong Way" signs positioned about 93 inches above the ground and 404 feet east of the crossroad. The ramp has no wrong-way arrow pavement markings and no "One-Way" arrow, "No Right Turn," or "No Left Turn" signs at the crossroad. (See figure 5.)

Figure 5. Likely wrong-way driver entry point for the Arlington, Texas, collision, with signage locations marked. Green arrow indicates direction of the wrong-way vehicle's travel.

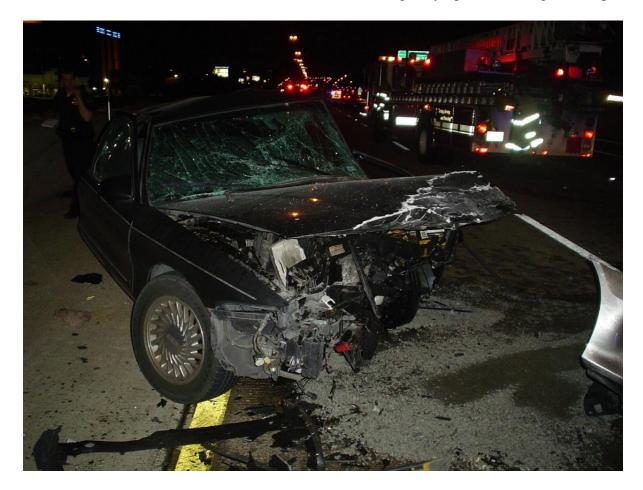
On Friday, August 12, 2011, about 2:00 a.m. central daylight time, a 1994 Lincoln Mark VIII coupe driven by a 31-year-old man was involved in a frontal offset collision while traveling the wrong way (northbound in the southbound lanes) in the number one lane on US Highway 75 in Dallas, Texas. Southbound witnesses indicated that the Lincoln was traveling about 80 mph and, despite the darkness, only its parking lights were illuminated. Approximately 600 feet south of the Forest Lane interchange on Highway 75, the left front of the Lincoln struck the left front of a southbound 2005 Honda Civic, which was driven by a 21-year-old woman and traveling at a witness-estimated speed of 60 mph. The impact of the faster, heavier Lincoln reversed the direction of the Honda, and the Honda rotated counterclockwise approximately 90 degrees before coming to rest facing east. The Lincoln rotated counterclockwise approximately 30 degrees and came to rest facing northwest on the median shoulder. Both drivers survived the collision but sustained serious injuries. (See figure 6.)

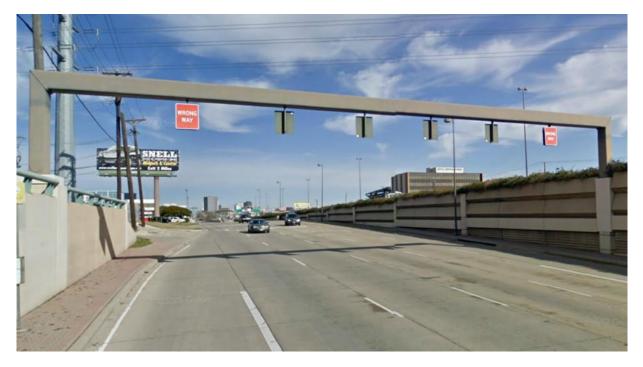
Investigators examined exit ramps in the vicinity of the collision site that channel vehicles from southbound Highway 75 to southbound North Central Expressway. The exit ramps are equipped with four 30- by 30-inch "Do Not Enter" signs positioned approximately 7 feet above the ground, facing south, parallel with the crossroad. The first two "Do Not Enter" signs are located about 25 feet north of the crossroad, and the two additional "Do Not Enter" signs are located about 600 feet farther north. In addition, two 24- by 36-inch "Wrong Way" signs are located 200 feet from the crossroad and elevated about 17 feet above the ground.⁴⁴ (See figure 7.)

Figure 7. Mounting height of wrong-way signs on frontage road adjacent to US Highway 75 in Dallas, Texas.

⁴⁴ Section 2A.18 of the *MUTCD* indicates that 17 feet is the minimum height for overhead signs.

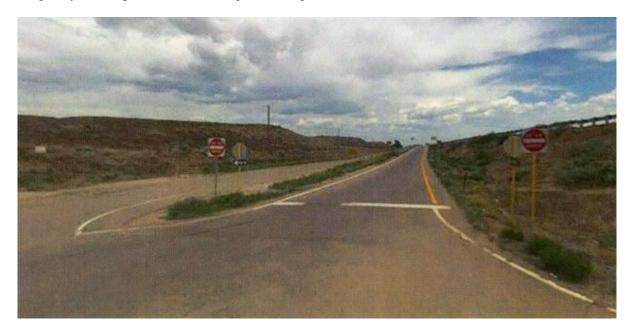
Exit ramps 119 and 122 are equipped with two 30- by 30-inch "Do Not Enter" signs positioned about 7 feet above the ground, facing south, parallel with the crossroad. Additionally, exit 119 has two 24- by 36-inch "Wrong Way" signs located 75 feet from the crossroad; this signage differs from exit 122, which has one 24- by 36-inch "Wrong Way" sign on the left, approximately 37 feet from the crossroad, and a second 24- by 36-inch "Wrong Way" sign on the right, 250 feet from the crossroad. Both ramps also have 12- by 36-inch "One-Way" signs posted about 5 feet above the ground at the crossroad. The ramps have no artificial lighting or wrong-way arrow pavement markings. (See figure 8.)

Figure 8. End of exit ramp 122, possible wrong-way driver entry point for the Fountain, Colorado, collision.

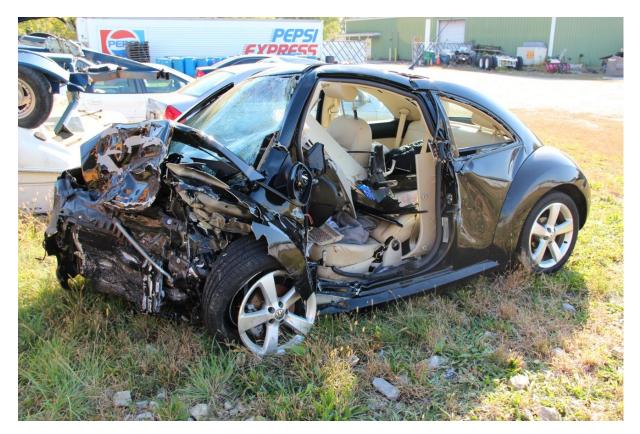
which caused the Chevrolet driver to be ejected. After this impact, the Volkswagen came to rest in the median shoulder, facing the Chevrolet in the number two lane and shoulder. The combination vehicle came to rest in the number two lane.

Figure 9. Damage to the wrong-way vehicle from the Beloit, Wisconsin, collision.

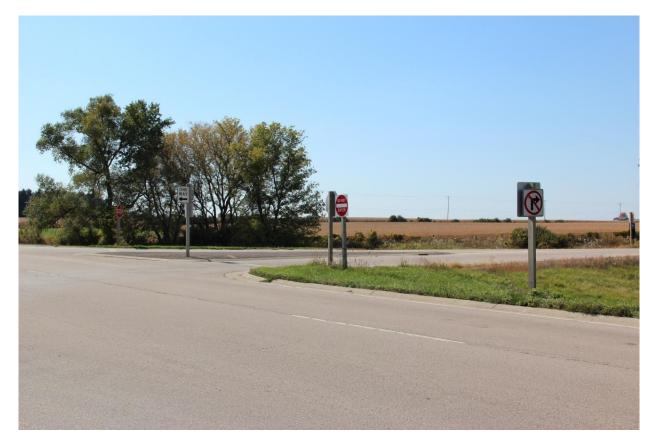
Based on witness statements and examination of entry and exit ramps in the area of the collision, NTSB investigators determined that the most likely wrong-way entry point was the exit ramp at State Route 140, which is about 3 miles from the collision site. However, investigators could not rule out the possibility that the Volkswagen began to travel the wrong way on I-43 by executing a U-turn or traversing the median.

The exit ramp for State Route 140 is equipped with a single "Do Not Enter" sign facing south on the right side of the ramp and two "Wrong Way" signs farther south and on each side of the ramp. There are "No Right Turn" and "No Left Turn" signs posted in each direction on the crossroad to warn drivers on State Route 140 against inadvertently entering the exit ramp. The ramp has no roadway lighting or wrong-way arrow pavement markings. (See figure 10.)

Figure 10. Possible wrong-way driver entry location for the Beloit, Wisconsin, collision.

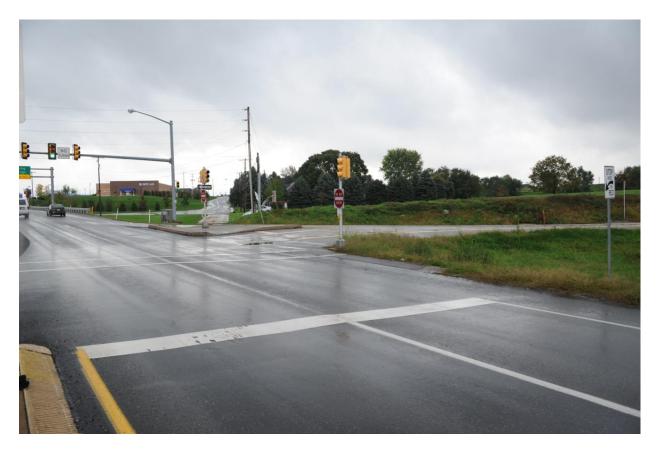
Access from the exit ramp to York Road (crossroad) is controlled by a traffic light. "No Turns" signs are mounted about 14 feet above the ground and adjacent to traffic lights on the crossroad, and a raised center median is present to prevent vehicles from turning left into the exit ramp. At the crossroad, two 30- by 30-inch "Do Not Enter" signs are posted about 5 feet above the ground, and two "One-Way" arrows are posted about 8 feet above the ground. Two 24- by 32-inch "Wrong Way" signs positioned about 8 feet above the ground are located about 65 feet south of the crossroad. Two wrong-way arrow pavement markings, about 12 and 24 feet long, respectively, are located approximately 130 feet south of the crossroad. (See figure 12.)

Figure 12. Approaching the wrong-way driver entry point for the Carlisle, Pennsylvania, collision. (Note: It was not raining when the collision took place.)

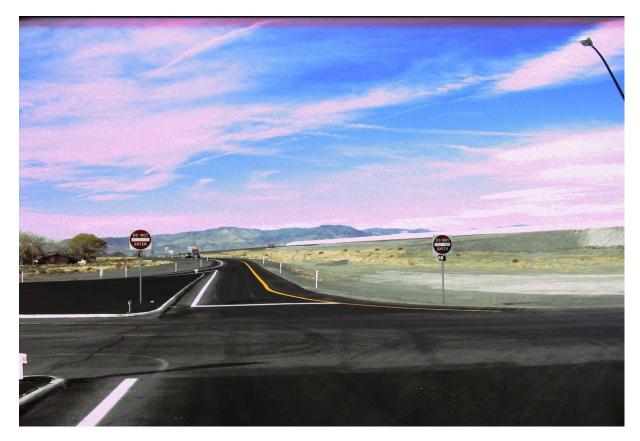
The Nevada State Patrol determined that the Mercedes began to travel the wrong way on I-80 by entering exit 48, about 2 miles east of the collision scene. The ramp intersects with State Route 343 and is equipped with the following warning signage: two 36- by 36-inch "Do Not Enter" signs and "One-Way" arrow signs about 6 feet above the ground; two 42- by 30-inch "Wrong Way" signs about 6 feet above the ground and 100 feet west of the crossroad; and a "No Right Turn" sign on State Route 343 to warn southbound vehicle drivers against inadvertently entering the ramp. (See figure 13 below.)

Figure 13. Likely wrong-way driver entry point for Fernley, Nevada, collision.

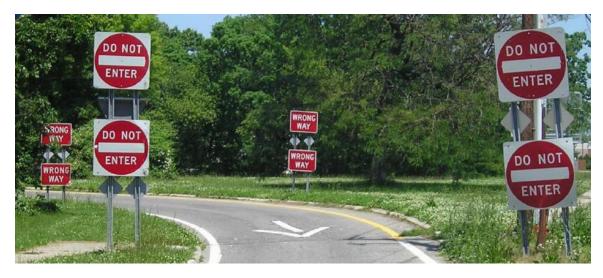
Figure 17. Double-posted "Do Not Enter" and "Wrong Way" signs on an exit ramp. (Courtesy of the New York State Department of Transportation).

- Posting controlled-access highway entrance signs on each side of entrance ramps¹¹²
- Applying red retroreflective tape to the vertical posts of exit ramp signs
- Installing red delineators on each side of exit ramps
- Installing LED-illuminated in-pavement markers or delineators parallel with the stop bar at the crossroad end of exit ramps
- Installing trailblazing lines or reflective markers that channel travel in an arc to guide motorists making a left turn from the crossroad into an entrance ramp, to keep them from inadvertently entering an exit ramp¹¹³
