Wrong-Way Driving

Special Investigation Report

NTSB/SIR-12/01 PB2012-917003

Highway Special Investigation Report

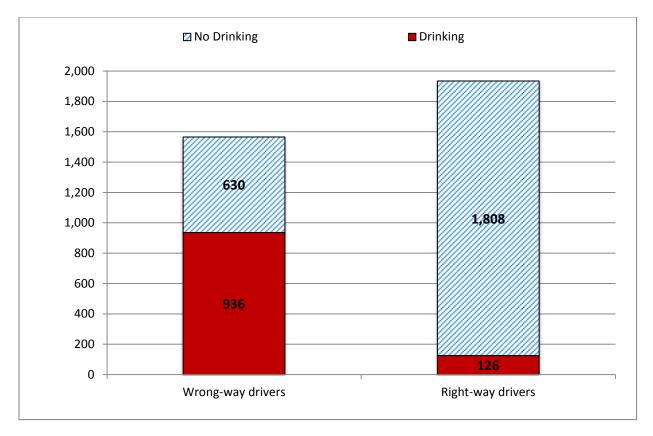
To determine the extent of alcohol impairment among wrong-way drivers, the NTSB examined drivers' blood alcohol concentration (BAC) levels and police officer assessments of alcohol impairment.²⁵ There were 1,566 wrong-way drivers in the multiyear FARS data set; of these, 936 wrong-way drivers (60 percent) had indications of alcohol involvement. By comparison, only 126 other drivers (6.5 percent) in the same fatal wrong-way crashes (referred to in figure 2 [see below] as "right-way drivers") had alcohol involvement. (Note: For the purpose of the analysis, the right-way drivers are those traveling in the legal direction of traffic flow and involved in the collision with the vehicle traveling on controlled-access highways at the time of the collision.)

Figure 2. FARS data indicating drivers involved in fatal wrong-way collisions on divided highways who showed indications of alcohol use; comparison between wrong-way and right-way driver drinking data (2004–2009). (Note: The larger number of right-way drivers reflects the fact that a wrong-way driver may collide with more than one vehicle.)

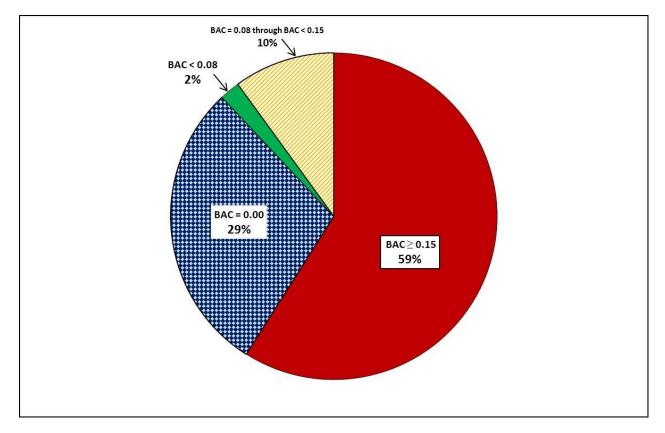
Although specific state laws and penalties vary, all states define alcohol-impaired driving based on a BAC at or above 0.08 percent. For the 1,150 drivers whose BAC was reported, 114 (10 percent) had BACs between 0.08 and 0.15, and 684 (59 percent) had a "high BAC" at or above 0.15.²⁶ (See figure 3.)

Figure 3. NTSB analysis of FARS data (2004–2009) showing reported BAC levels of wrong-way drivers.

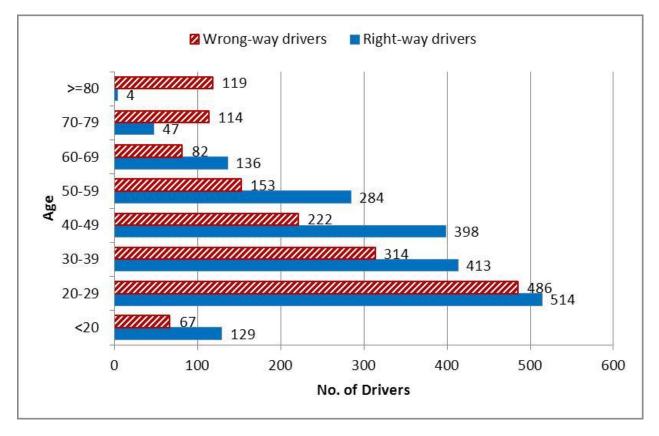
Figure 4. Ages of drivers involved in fatal wrong-way collisions on divided highways; comparison between wrong-way and right-way driver ages (2004–2009). (Note: The larger number of right-way drivers reflects the fact that a wrong-way driver may collide with more than one vehicle.)

The majority of wrong-way drivers were between the ages of 20 and 50. There were fewer wrong-way than right-way drivers in every 10-year age category below age 70. In the age categories above 70, however, the opposite was true, and the number of wrong-way drivers greatly exceeded the number of right-way drivers; there were almost $2\frac{1}{2}$ times more wrong-way drivers for ages 70–79, and almost 30 times more for ages above 80.

The NTSB's FARS analysis determined that drivers over the age of 70 are over-represented in fatal wrong-way crashes. Figure 4 in section 1 of this report shows the ages of wrong-way drivers involved in fatal collisions (2004–2009) and, as a comparative sample, looks at right-way drivers who were involved in those collisions. The bar chart shows that right-way drivers over the age of 70 represent less than 3 percent of all right-way drivers involved in fatal wrong-way drivers over the age of 70 account for about 15 percent of the wrong-way drivers involved in such collisions.

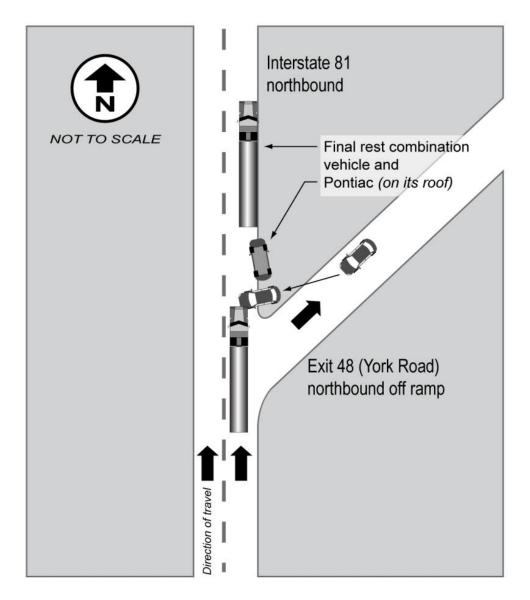
On Thursday, October 6, 2011, about 2:52 p.m. eastern daylight time, an 87-year-old woman driving a 1996 Pontiac Grand Am southeast on York Road in Carlisle, Pennsylvania, turned right one block earlier than intended and entered an exit ramp for vehicles exiting the northbound lanes of I-81. After traveling the full length up the exit ramp, the Pontiac driver made about a 150-degree clockwise turn at its top, attempting to enter northbound I-81 mainline traffic at an oblique angle. Just as the Pontiac began to enter this lane, traveling 10–15 mph, its left front was struck by the right front corner of a northbound 2008 Volvo truck-tractor semitrailer operated by a 30-year-old male driver traveling about 45 mph in the number two lane with vehicle headlamps illuminated. The Pontiac rotated clockwise, overturned, struck a guardrail, and came to rest on its roof facing south. (See figure 11.)

Figure 11. Diagram of Carlisle, Pennsylvania, collision.

The truck driver indicated that he applied the brakes just before the collision. The Pontiac driver, who was restrained by a three-point lap/shoulder belt, died 23 days after the collision as a result of injuries she sustained; the truck driver was not injured. The collision sequence was recorded on a dash-mounted video camera in a Pennsylvania State Police patrol car that was traveling northbound on I-81 adjacent to the combination vehicle.

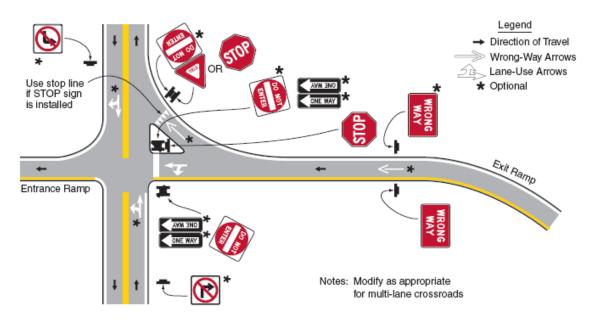
Figure 15. Required and optional signing and pavement markings. (Courtesy of the Federal Highway Administration.)

Optional signage additions would be to install "Freeway Entrance" signs; more "One Way," "Do Not Enter," or "Wrong Way" signs; or turn prohibition "No Right Turn" or "No Left Turn" signs on the crossroad. With respect to pavement markings, a slender, elongated wrong-way pavement arrow or bidirectional red-and-white raised pavement markers in the shape of an arrow may be provided to warn road users that they are traveling the wrong way on an exit ramp. The *MUTCD* recommends, but does not mandate, that double solid yellow lines be placed on two-lane paved crossroads and that lane use arrows be visible in each lane of an exit ramp whenever crossroad channelization or ramp geometrics are not adequate to prevent wrong-way movements. According to AASHTO, channelization is any "at-grade separation or regulation of conflicting traffic movements into defined travel paths by pavement markings, raised islands, or other suitable means to facilitate the safe and orderly movement of vehicles and pedestrians." (See figures 15 and 16.)

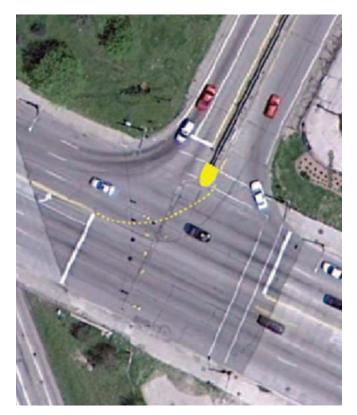
Figure 16. Example of channelization methods for a paired controlled-access highway ramp location, including a painted island and a left-turn marking extension from the crossroad. (Courtesy of the Federal Highway Administration.)

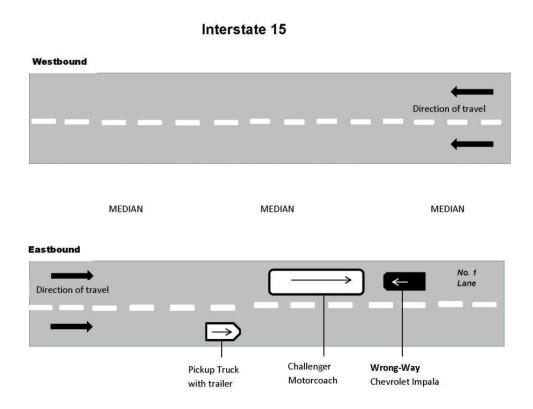
Figure A-1. Highway and vehicle elements of Baker, California, wrong-way collision. (Note: Diagram is not based on accident mapping or drafted to scale.)

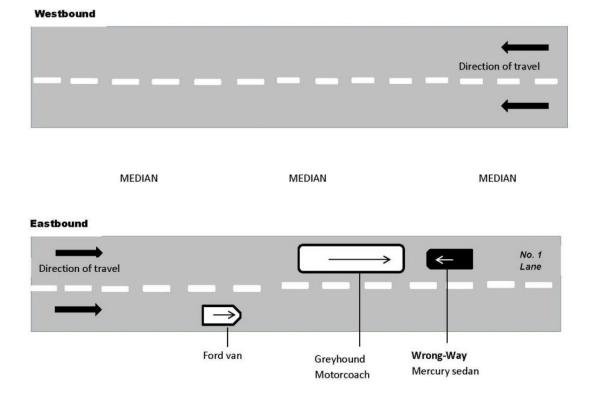
Dulles, VA, Airport Access Road

Figure A-2. Highway and vehicle elements of Dulles, Virginia, wrong-way collision. (Note: Diagram is not based on accident mapping or drafted to scale.)

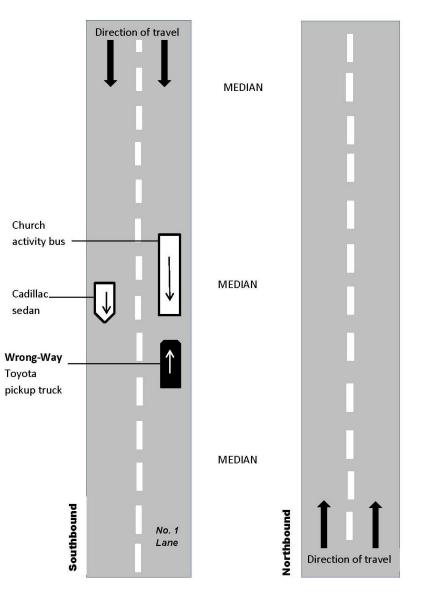
Interstate 71

Figure A-3. Highway and vehicle elements of Carrollton, Kentucky, wrong-way collision. (Note: Diagram is not based on accident mapping or drafted to scale.)

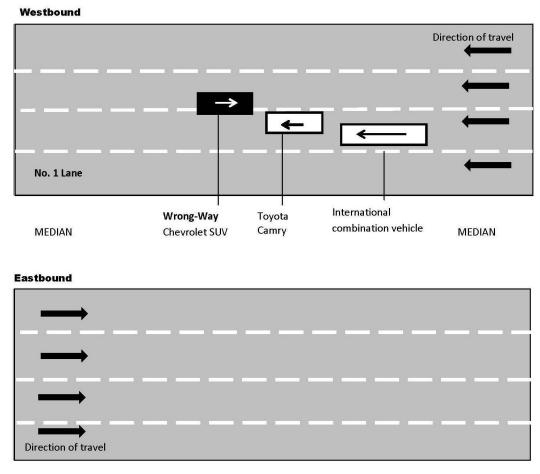
Figure A-4. Highway and vehicle elements of Arlington, Texas, wrong-way collision. (Note: Diagram is not based on accident mapping or drafted to scale.)

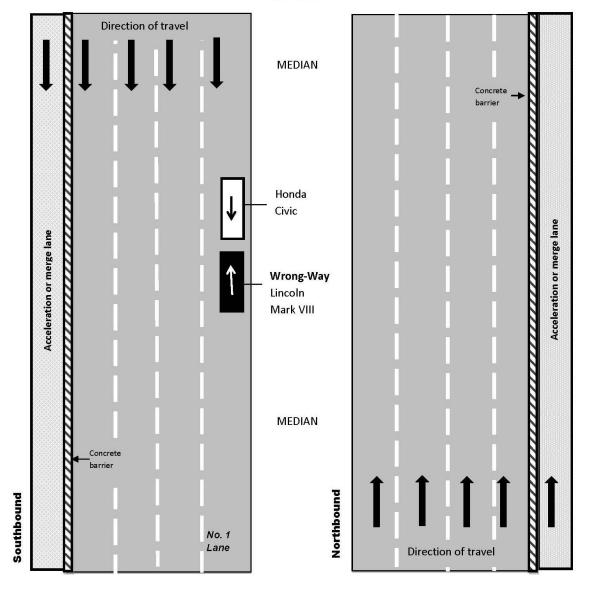
US 75

Figure A-5. Highway and vehicle elements of Dallas, Texas, wrong-way collision. (Note: Diagram is not based on accident mapping or drafted to scale.)

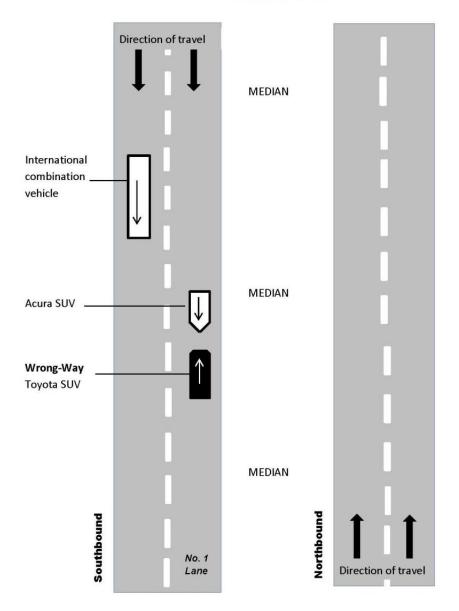
Interstate 25

Figure A-6. Highway and vehicle elements of Fountain, Colorado, wrong-way collision. (Note: Diagram is not based on accident mapping or drafted to scale.)

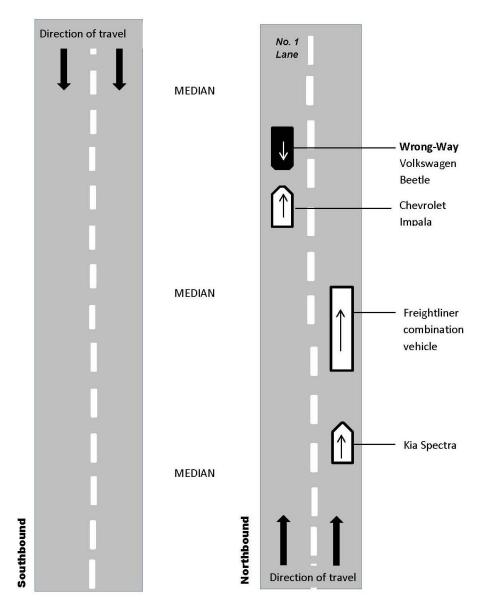
Interstate 43

Figure A-7. Highway and vehicle elements of Beloit, Wisconsin, wrong-way collision. (Note: Diagram is not based on accident mapping or drafted to scale.)

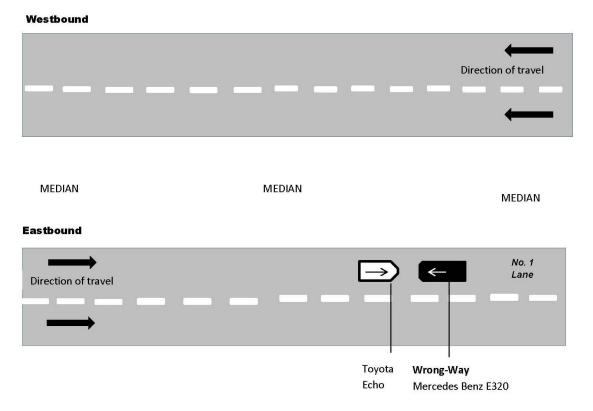
Interstate 80

Figure A-8. Highway and vehicle elements of Fernley, Nevada, wrong-way collision. (Note: Diagram is not based on accident mapping or drafted to scale.)
